Kent Road Protected Bike Lanes, Pascoe Vale

Road Safety Audit

Audit Stage: Post Construction

Report for Moreland City Council

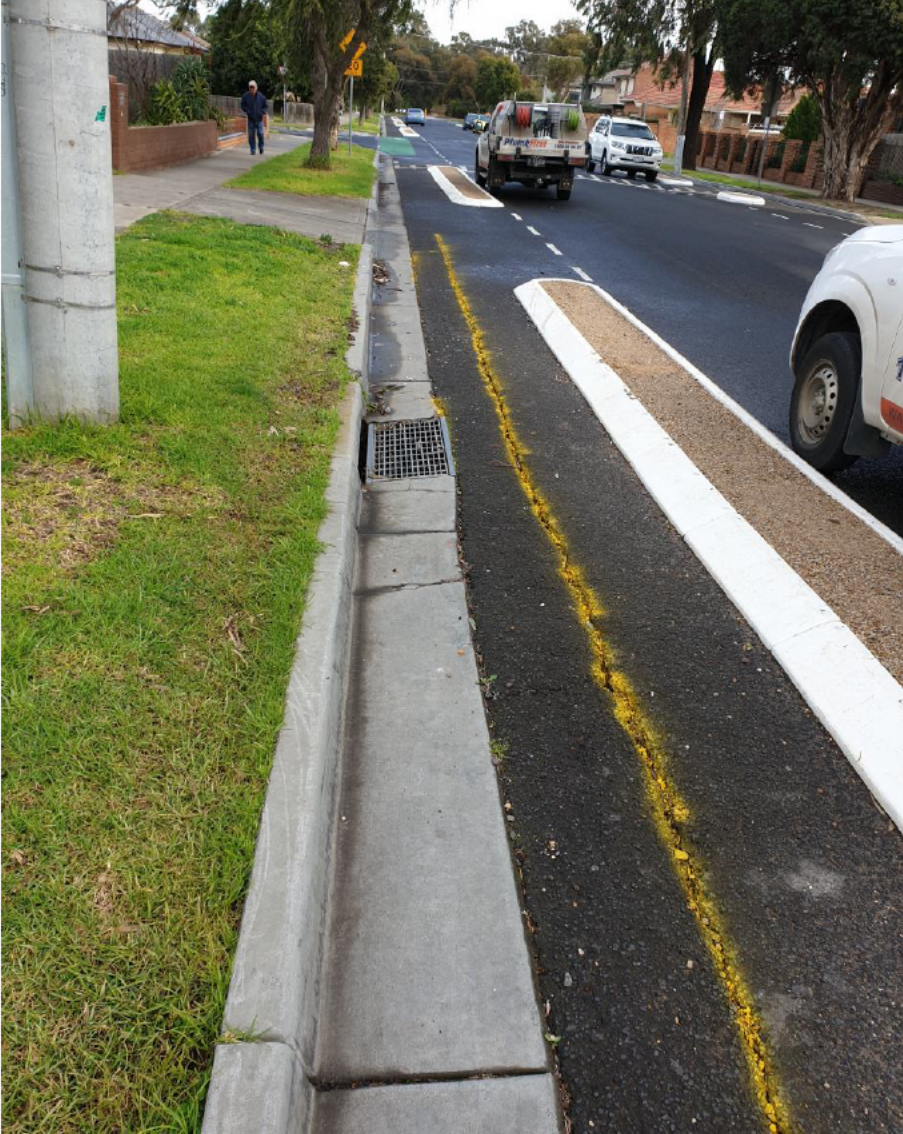
Audit Findings	Level of Risk	Safe System Energy	Recommendations P – Primary ST – Step Towards S – Supporting N – Non-Safe System	Responsible Officer	
				Accept Yes/No	Comments
a) Cycle path issues					
<p>i) On the westbound bicycle path just east of Valerie St, there is a longitudinal groove on the path surface that may be hazardous to cyclists. Narrow bicycle wheels can get caught and tramline in this groove.</p> <p>It appears to already have been identified as a hazard and highlighted with some yellow paint.</p>

Probable Minor HIGH	Within tolerable limits	Consider resurfacing the path to remove these grooves (S)

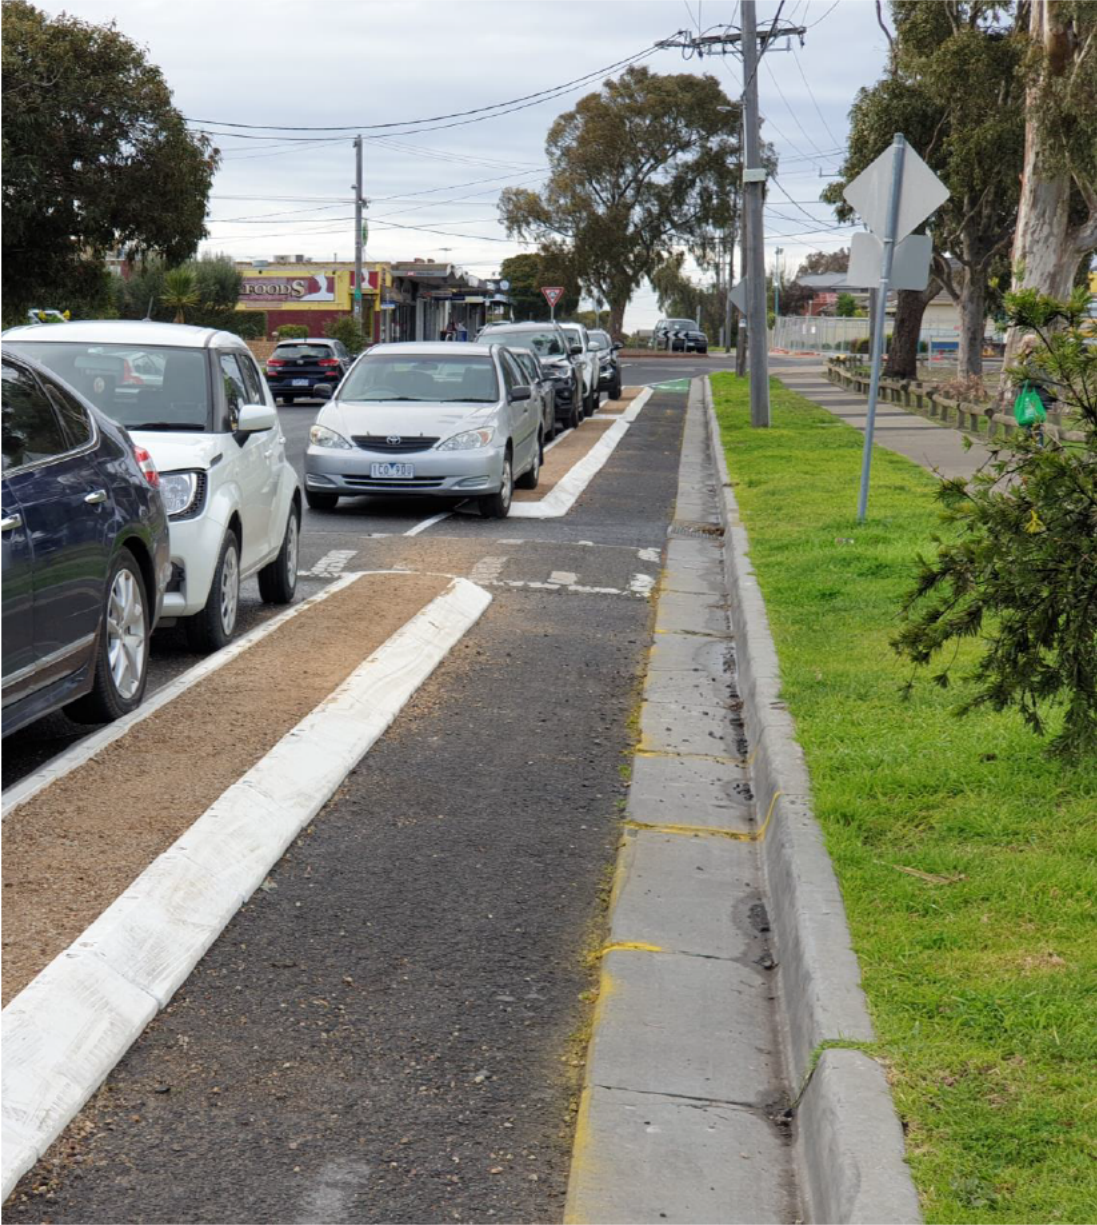
Audit Findings	Level of Risk	Safe System Energy	Recommendations P – Primary ST – Step Towards S – Supporting N – Non-Safe System	Responsible Officer	
				Accept Yes/No	Comments
<p>ii) Cycle paths are formed kerbside by the installation of a 1.0m wide temporary separator, positioned to provide approx. 1.2m cycle path width between kerb and separator. However the kerb channel forms part of this path width.</p> <p>The join between the channel lip and asphalt road/path forms a level change or a groove that may trap narrow bicycle tyres and may be hazardous to cyclists. This may be exacerbated over time as the asphalt and concrete parts of the path settle and form step changes in the surface.</p>

Occasional Minor MEDIUM	Within tolerable limits	If space permits, consider widening the path to min 1.2m excluding the drainage channel, so that cyclists are less likely to contact this groove. (S)

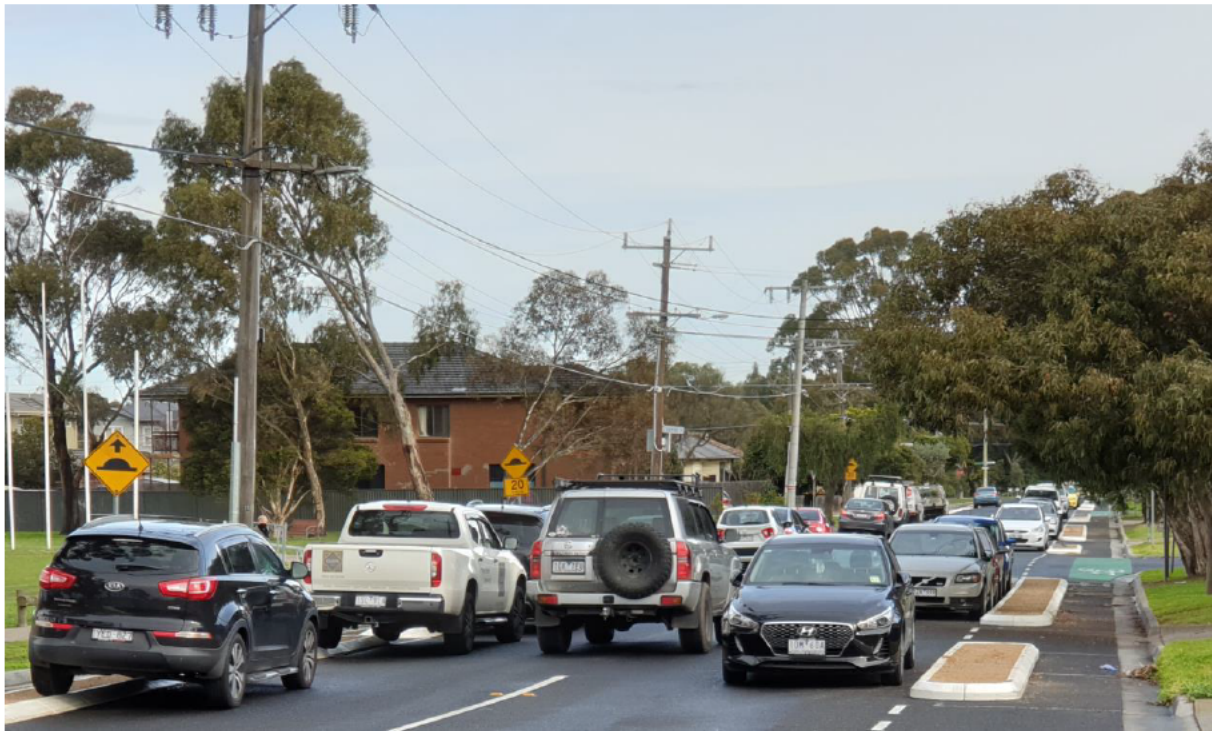
b) Roadway width					
<p>The trafficable roadway width has been reduced due to the provision of the new cycle paths. Previously, the width of Kent Road accessible to motor vehicles was sufficient for vehicles four-abreast (two parked kerbside plus two concurrent traffic lanes). Two-way traffic were not required to take turns to pass.</p> <p>Post the installation of the protected cycle paths, the residual roadway width is in the vicinity of 7.5m wide. Where cars are parked on both sides (as is the case in areas of high parking demand), two-way traffic must take turns to pass, as illustrated in the photo below.</p>

<p>While this method of traffic operation is not inherently unsafe, a hazard may arise when the habitual behaviour of local drivers overrides any recognition of the new traffic layout. Drivers who are used to driving this street without having to take turns with oncoming traffic can experience cognitive dissonance and fail to perceive the risks when approaching another vehicle. As a result, they may also fail to take the appropriate evasive action. This is usually followed by a collision and much blaming of third parties, which are typical outcomes from driver cognitive dissonance.</p> <p>The risk outlined above is highest immediately after changes are implemented, and decay as drivers recognise that change has occurred and get used to the new layout.</p>	Occasional Minor MEDIUM	Within tolerable limits	Consider temporary signage to bring to the attention of all drivers that road conditions have changed. (S) An example sign is shown below.

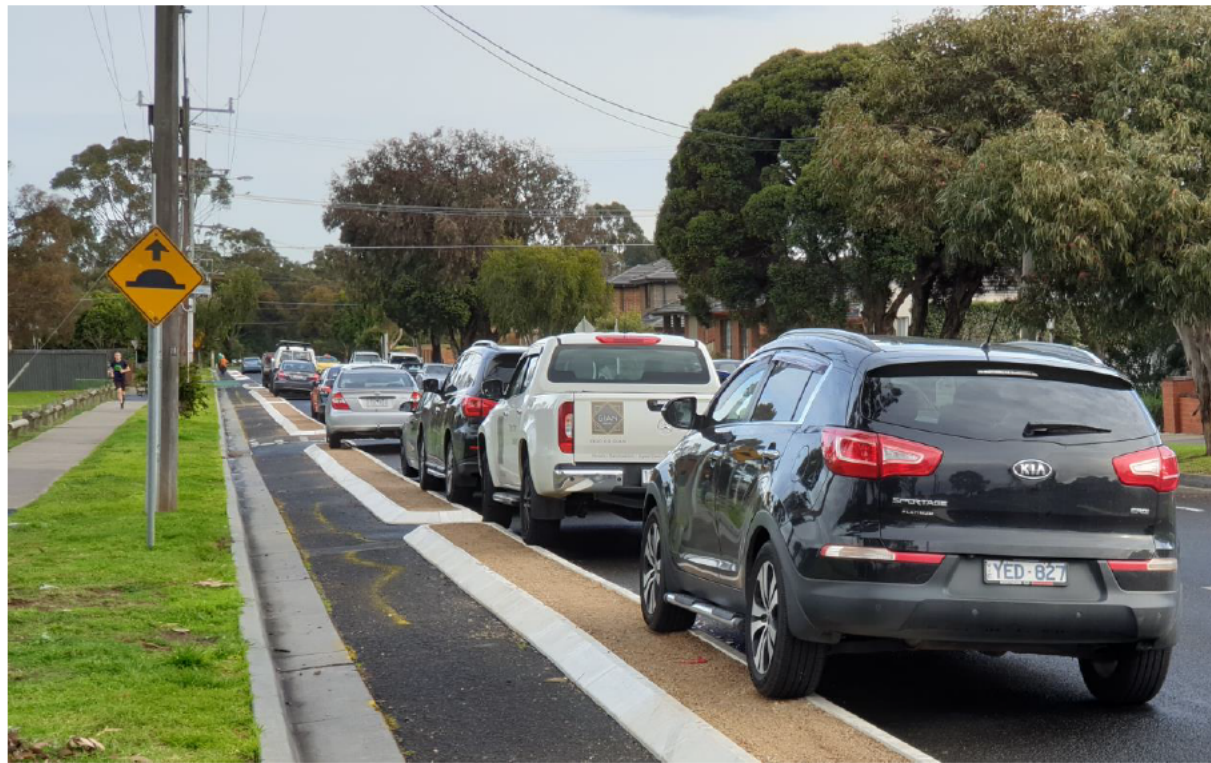
c) Parking					
<p>i) At the time of the daytime site visit, several cars were observed to have parked one wheel up on the temporary separators on the south side of Kent Road. This appears to be related to the use of semi-mountable kerb for this separator as this effect was not observed on the north side of Kent Road where a more upright barrier kerb design is used.</p> <p>Cars parking on the separators may be a hazard because:</p> <ol style="list-style-type: none"> 1. there is reduced buffer space between the parked car and the cycle path, which increases the risk of car dooring to cyclists. 2. Parking movements may be erratic as vehicles mount the kerb and may be harder to control. 	Improbable Minor LOW	Within tolerable limits	Consider replacing the mountable kerb separators with barrier kerb (S) Consider installing flexible bollards on the kerb separators. (S)
